### Forecasted Low-Low Tide Stage (No Transfers)

#### Middle River at Howard Road Bridge

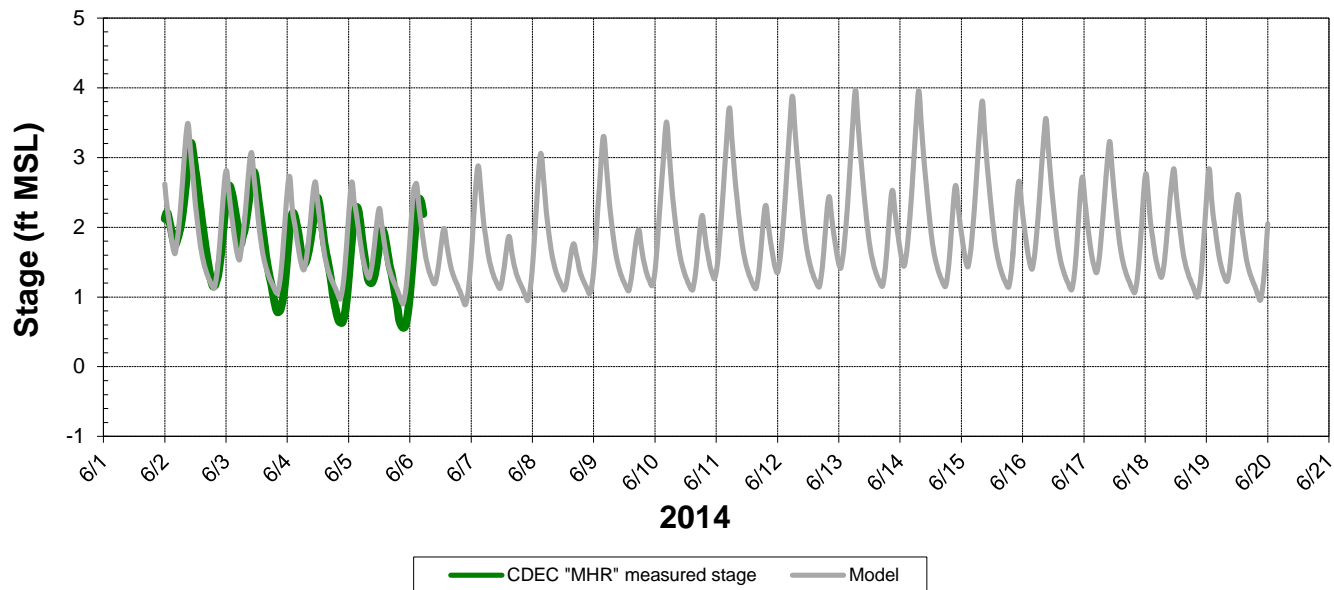
Note: SHORB out 6-6-14, all culvs. open ; MR in, all culvs. tidal; ORT in, all culvs. tidal;  
GLC fully in 6-3-14 with all culvs. tied open

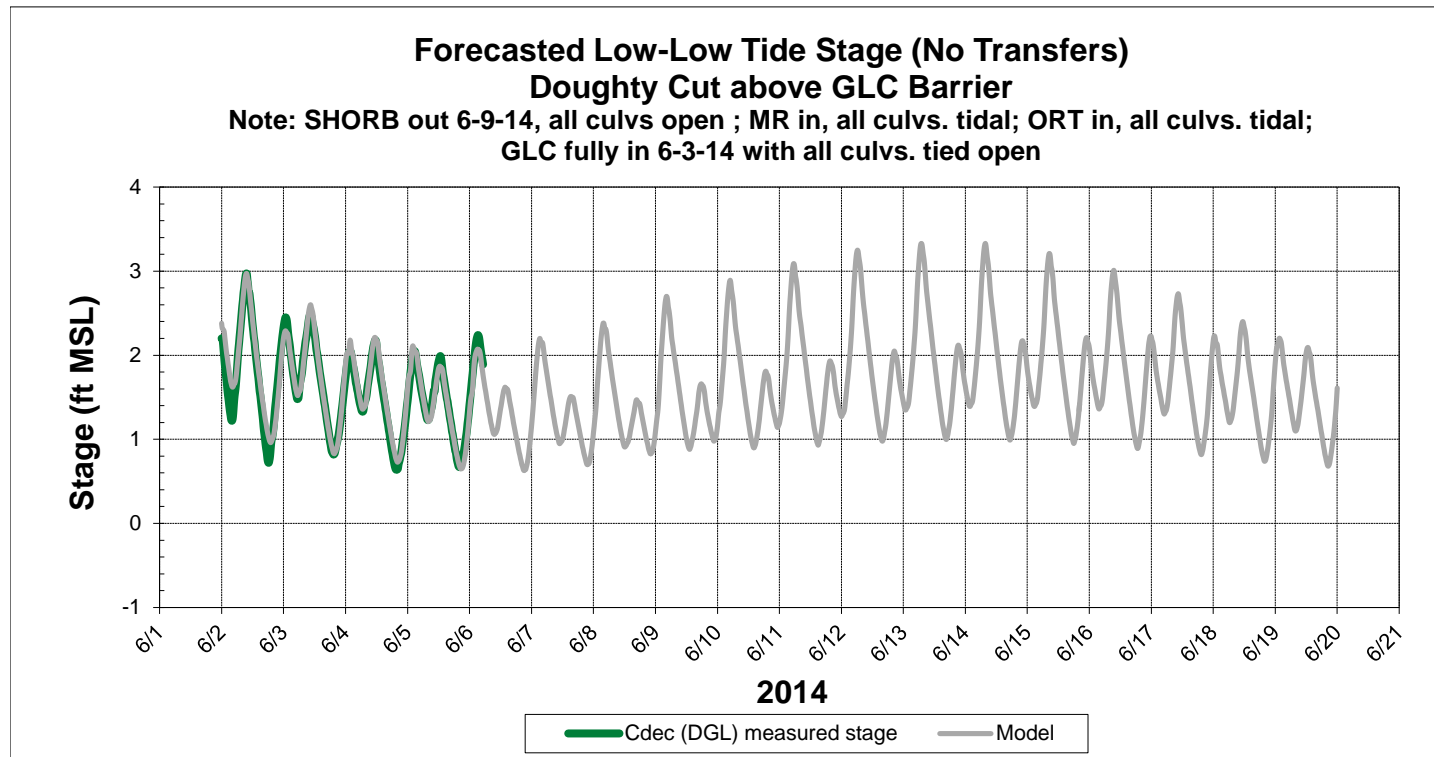
Assumptions:

- SHORB in on April 8, 2014 with all 8 culvert slide-gates open until the June 9th planned breach.
- MR barrier in on March 17, 2014, with all 6 flap-gates operating tidally as of 4-8-2014 .
- ORT barrier in on April 3, 2014 with all 9 flap-gates operating tidally as of 4-8-2014 .
- GLC in (fully closed) on June 3, 2014, with all 6 flap-gates tied open.

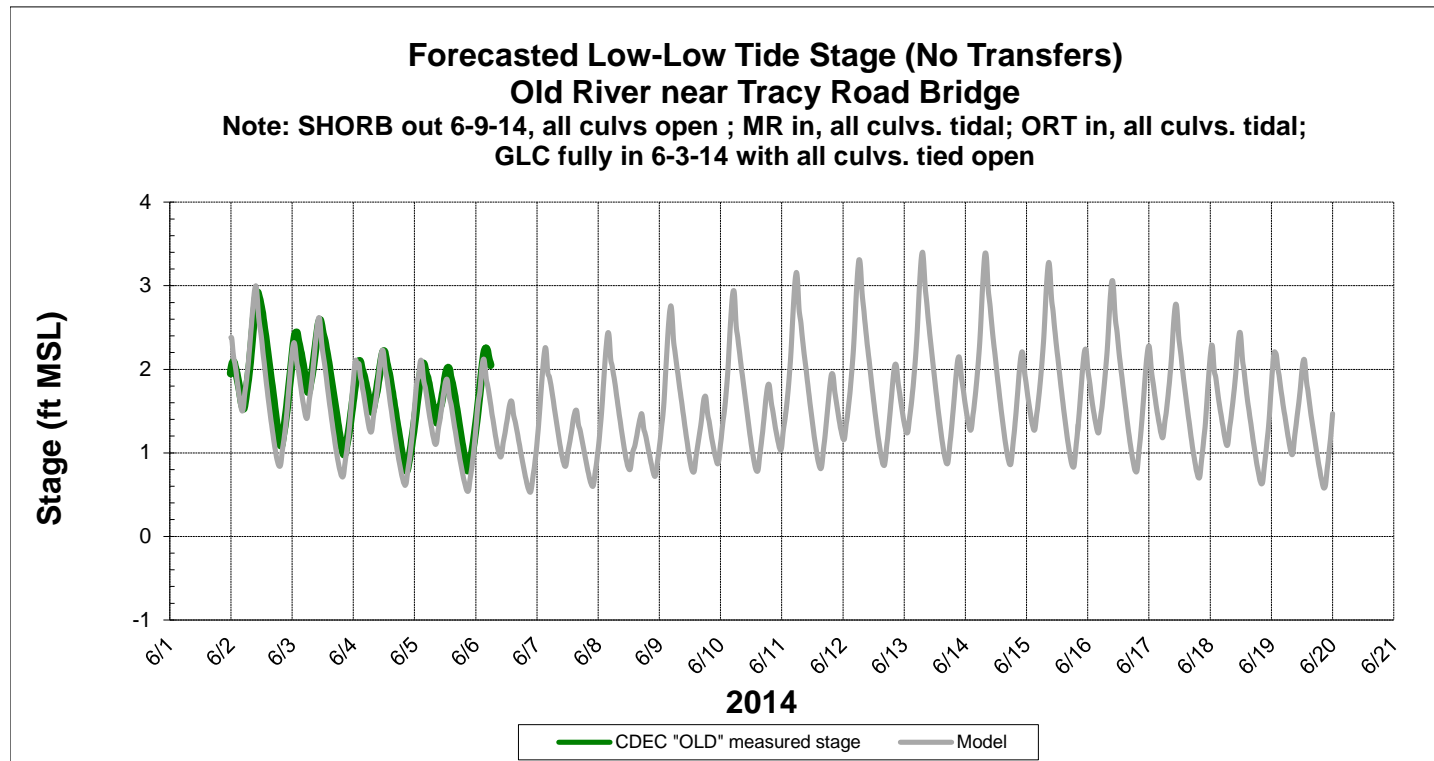
Assumptions:

- SHORB in on April 8, 2014 with all 8 culvert slide-gates open until the June 9th planned breach.
- MR barrier in on March 17, 2014, with all 6 flap-gates operating tidally as of 4-8-2014 .
- ORT barrier in on April 3, 2014 with all 9 flap-gates operating tidally as of 4-8-2014 .
- GLC in (fully closed) on June 3, 2014, with all 6 flap-gates tied open.
